Degree Project in Environmental Engineering and Sustainable Infrastructure

# **Assessment of the Triggers for Excessive Filamentous Algal Growth in Stormwater Ponds and Preventive Management**

Study cases in Uppsala

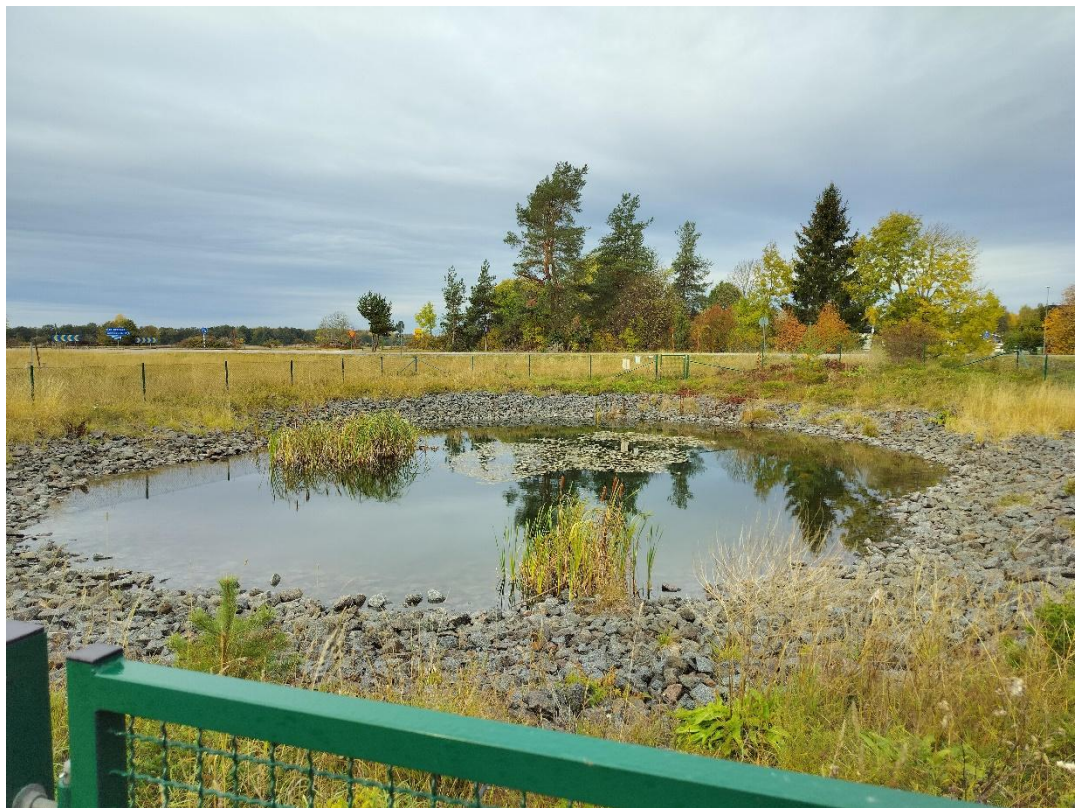
*Figure 4: Pond at Ekåkersvägen in Rörby/Bälinge captured from the south on October 8, 2024 (photo by Margarita Judina).*

The SWP in Rörby/Bälinge was constructed in 2016 for stormwater retention. It is located approximately 12 km northeast of Uppsala city center, in Bälinge. The total catchment area of the pond is estimated at 8.2 hectares, while the effective contributing area is 1.5 hectares.

The catchment consists of single-family villas, green spaces, pedestrian and bicycle paths, and roads (Uppsala Vatten, 2023a). The pond is surrounded by a security fence, as shown in Figure 4, but it can be accessed if needed through two unlocked gates.

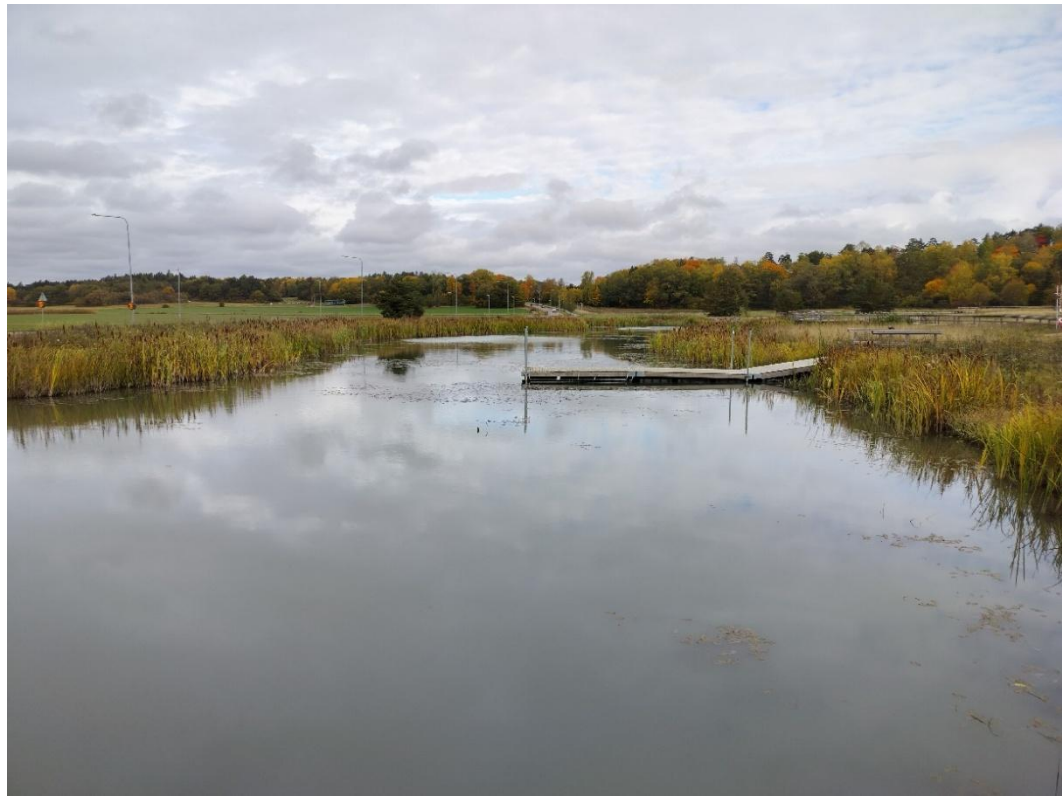
*Figure 5: Gottsunda Stormwater Park captured from the south on October 8, 2024 (photo by Margarita Judina).*

The design of the pond includes three pre-sedimentation ponds, the main pond, seen in Figure 5, which has the average water surface area of about 4 500 m<sup>2</sup>, volume of 5 200 m<sup>3</sup> and average depth of 1,15 meter, and an open ditch paved with stones that connects one of the pre-sedimentation ponds with the main pond. The slopes of the eastern side of the pond are gentle, with an incline of 1:8,

allowing for water level fluctuations over a shallow area. In contrast, the slopes on the western side are steeper, varying between 1:3 to 1:5 incline (Stenström et al. 2019).

The bottom of the pond consists of a dense clay layer that was originally present on the site. According to the system description document by Stenström et al. (2019), some water infiltration into the clay material is expected, and coarser materials may have been placed along the shores to create diverse environments.

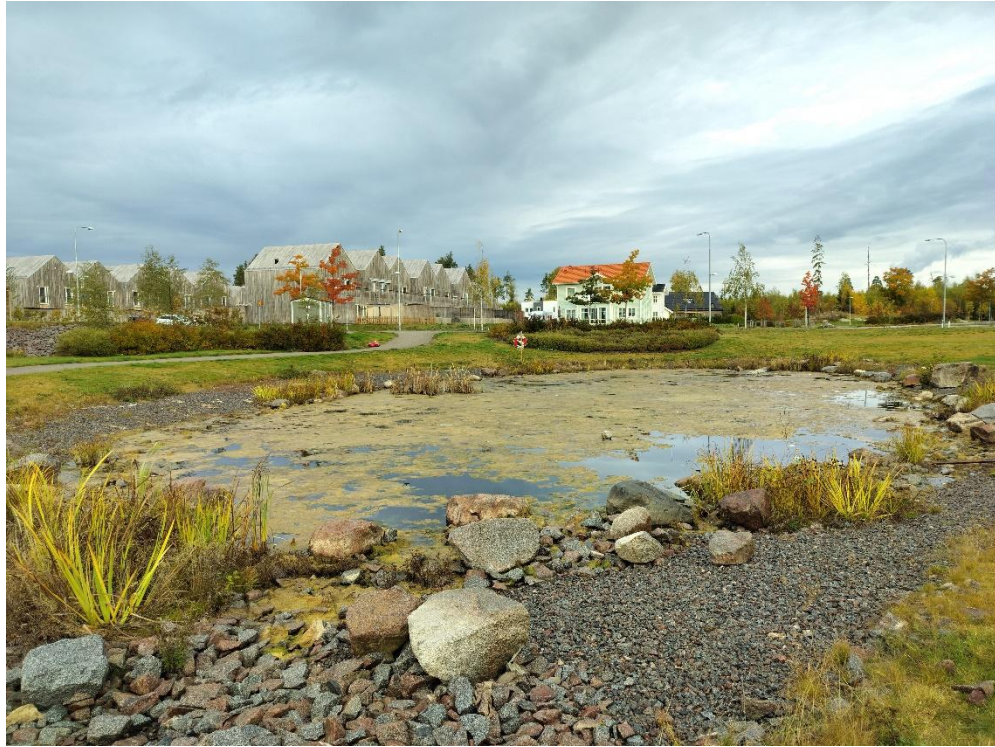
*Figure 6: Southern Pond at Fjärdermolnsvägen, Fullerö captured from the south on October 8, 2024 (photo by Margarita Judina).*

The southern pond, shown in Figure 6, receives water through a stone-paved ditch that runs along the playground and green area in the south, as well as from an inlet on the northwest side. Its outlet directs water to the northern pond, which has two additional inlets: one from a stone-paved ditch in the northeast and another from an inlet pipe in the east. Water from the northern pond is discharged into the stormwater pipe system, which eventually leads to another pond before flowing through a ditch into Fyrisån and ultimately reaching Lake Mälaren (Uppsala Vatten, 2023b).

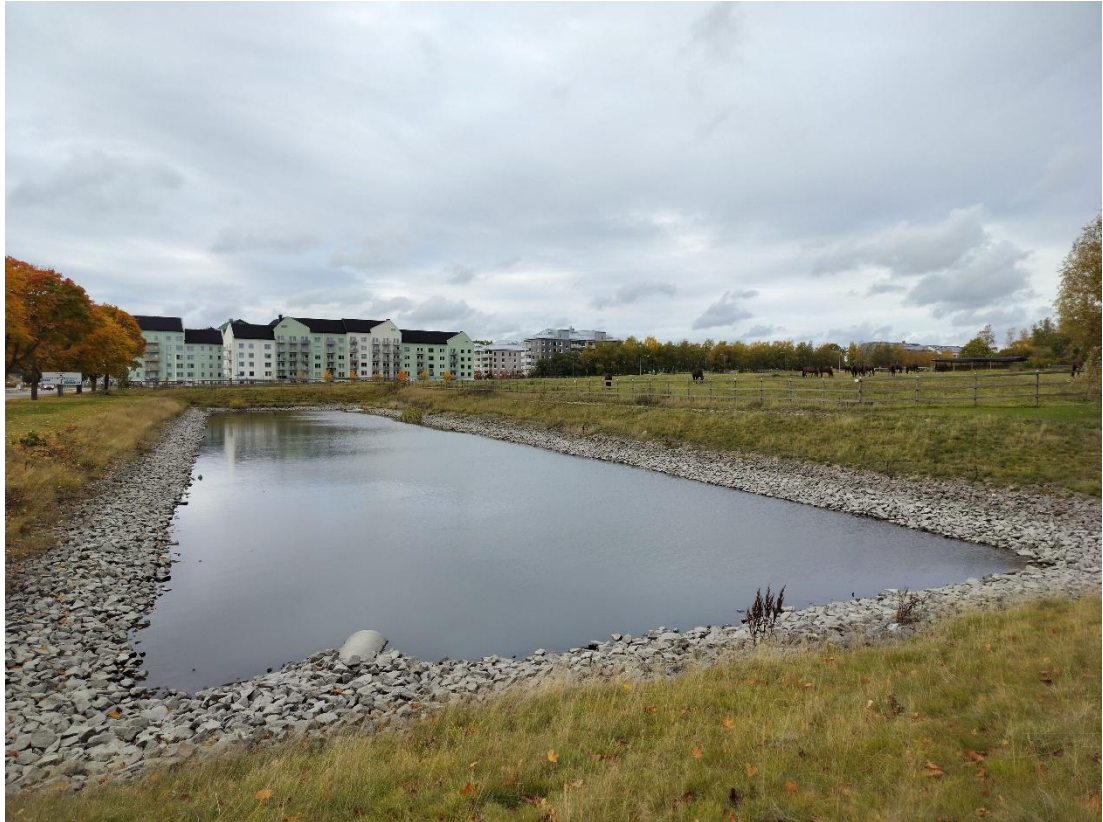
*Figure 8: The pond in Ultunaallén, view from the east on October 8, 2024 (photo by Margarita Judina).*

In the report performed by Norconsult (2024b) it is observed that the slopes of the pond are maximum 1:6, it has an average depth of 1.2 m and a permanent surface area of 2600 m<sup>2</sup>. According to the illustrations on the same document, the pond has a pre-sedimentation section (fördamm), separated from the rest of the pond by an elevation in the soil, with slopes of around 1:3, as shown in Appendix F.

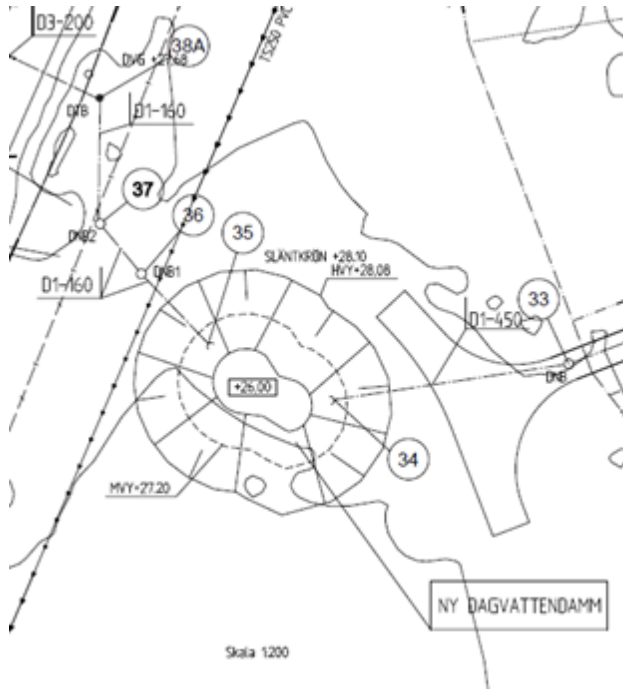
Figure F- 1: Floor plan. Bålinge. Extracted from drawing provided by Uppsala Vatten (Uppsala kommun, 2013).
